# Acoustic Detection of Faults and Degradation in a High-Bypass Turbofan Engine During Vehicle Integrated Propulsion Research (VIPR) Phase III Testing

Devin K. Boyle<sup>1</sup>

*NASA Armstrong Flight Research Center, Edwards, California, 93523*

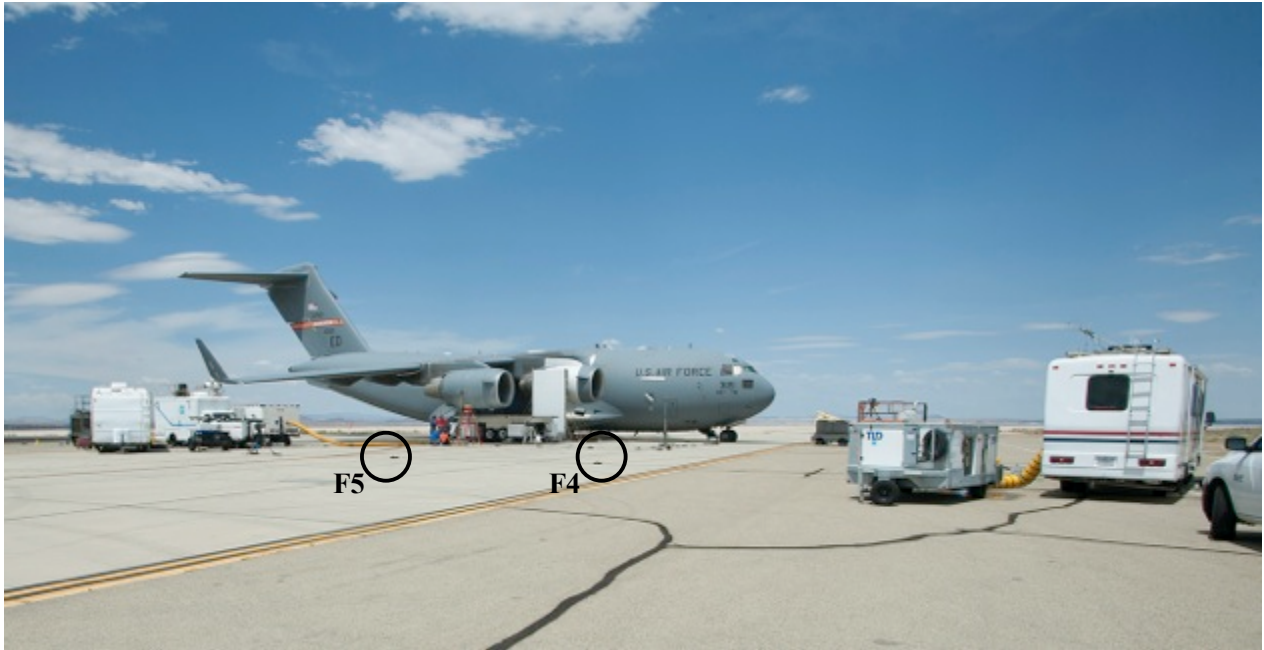
**Figure 1. Test setup, showing aircraft and microphones F4 and F5 (Photo courtesy: NASA photograph ED15-0188-165).**

The VIPR III testing was performed on a concrete taxiway capable of accommodating the USAF C-17A at full power. Surrounding areas included a mixture of asphalt or concrete, a transition from the pavement to gravel, and finally a desert scrub environment. A representative test setup, showing the aircraft and corresponding hardware orientation, is shown in Fig. 1. It should be noted that this test is far from ideal acoustically. The test area contains many noise sources adjacent to the source (engine)-receiver (microphone) vector. Some extraneous noise sources included air conditioning and ground power carts, compressors, dryers, and the aircraft auxiliary power unit. This analysis intends to analyze trends in the total noise received by the microphones in different locations to suggest an overall degradation in engine condition as a result of volcanic ash ingestion. As such, the relative nature of the signals allows for a more qualitative approach free from the burden of source isolation and elimination. It is assumed that no substantial changes occurred to ancillary equipment during the testing period.

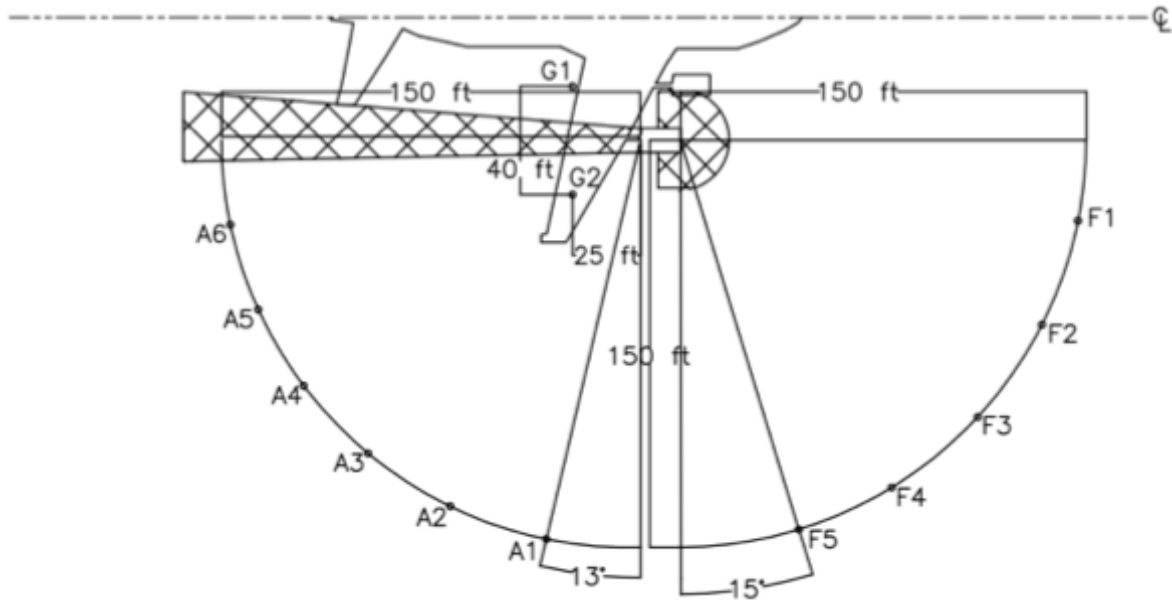
**Figure 2. Far-field radial array with microphones F1-F5 and A1-A6 and near-field microphones G1 and G2 positioned behind exhaust plane.**

Instrumentation used for data acquisition involved two independent systems for different sets of microphones requiring different recording rates. The first set was a radial array of 11 Brüel & Kjær (B&K) (Naerum, Denmark) Type 4191 ½-inch free-field acoustic microphones oriented at constant 150-ft radii relative to the inlet and core exhaust planes, respectively. The distance corresponds to 60 core exhaust nozzle diameters, which was assumed to be sufficient for far-field conditions to prevail at the microphone. A set of B&K Type 2690 amplifiers provided a 200-V polarization voltage to the microphones, as well as a high-pass filter (20 Hz, to reduce the influence of wind noise). From the amplifiers, the signal was sent to a Ling Dynamic Systems (LDS) Dactron brand Focus II analog to digital recorder, which allowed real-time viewing of the microphone signals on a laptop. The signals were recorded at 65,536 samples/second simultaneously for all channels at a 24-bit resolution. An embedded IRIG-B time code record was included in each channel. Microphone calibrations were performed with a B&K Type 4231 sound calibrator piston-phone providing a 1000 Hz tone at 114 dB. The calibrations were performed at the beginning and end of each test day for each microphone, when there was sufficient time to do so. Otherwise, as many microphones as possible were calibrated before testing began. The multiple daily calibrations were not necessary, however, since there was no appreciable variation in the signal of a given microphone over several days. At any rate, each microphone was compared with its own signal over various days of testing.

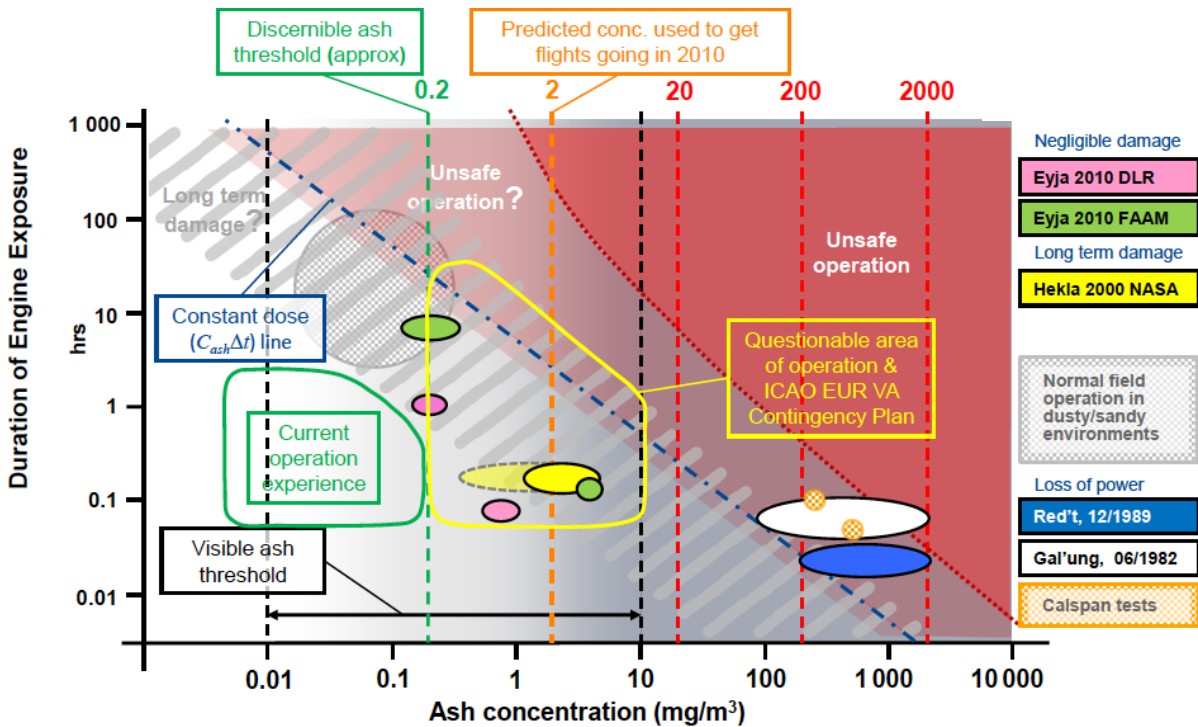
**Figure 3. Relationship between volcanic ash concentration and duration as drivers of flight safety and in the context of historical ash encounters. (Used with permission, © 2015 Rolls Royce PLC<sup>2</sup>).**

One of the most significantly degrading conditions to which the test engine was exposed was the ingestion of volcanic ash in relatively low concentrations for long durations.<sup>2</sup> Figure 3 shows the relationship between exposure duration and concentration of distal ash in the atmosphere. Superimposed on the figure, from left to right, are concentrations/durations that are believed to be economically damaging (not posing danger to the flight, but damaging components irreparably), an unknown region of concentration/exposure duration combination that may be unsafe, followed by a region in which unsafe operation is expected to be certain. The colored ovals correspond to some research flights at low ash concentrations as well as some unintentional encounters that resulted in major engine damage.<sup>3</sup> The VIPR III test points, not shown in the figure, were in the region near the orange dashed line for  $1 \text{ mg/m}^3$  for approximately 10 hr and along the black dashed line for  $10 \text{ mg/m}^3$  for approximately 10 hr of runtime. The VIPR testing personnel chose these points to bridge either side of the  $2 \text{ mg/m}^3$  concentration defined in 2010 by the London Volcanic Ash Advisory Center and provided to European aviation authorities that were expected to be hazardous to flight operations during the 2010 eruption of the Icelandic volcano Eyjafjallajökull. The  $2 \text{ mg/m}^3$  threshold is shown in Fig. 3 by the vertical orange dashed line. See Ref. 4 for an example of the ash advisories issued to aircraft; the areas enclosed in red are considered hazardous to aircraft operations.

One prominent example of an inadvertent ash encounter occurred when a NASA DC-8 airplane (McDonnell Douglas, now The Boeing Company, Chicago, Illinois) flew through a diffuse volcanic ash cloud from the Mt. Hekla volcano,<sup>5</sup> estimated by the yellow oval on Fig. 3. The engine damage resulting from the encounter necessitated the removal and overhaul of all four engines. In this case, the pilots had no conventional indications of an ash encounter. The only indications came from some very sensitive and specialized instruments which were on board the aircraft for use during the NASA SAGE III Ozone Loss and Validation Experiment (SOLVE) science mission. The images of the DC-8 CFM56 first stage high-pressure turbine blades in Fig. 4 clearly show volcanic ash clogging the turbine cooling passages (left) as well as erosion of the leading edges of the blades (right).

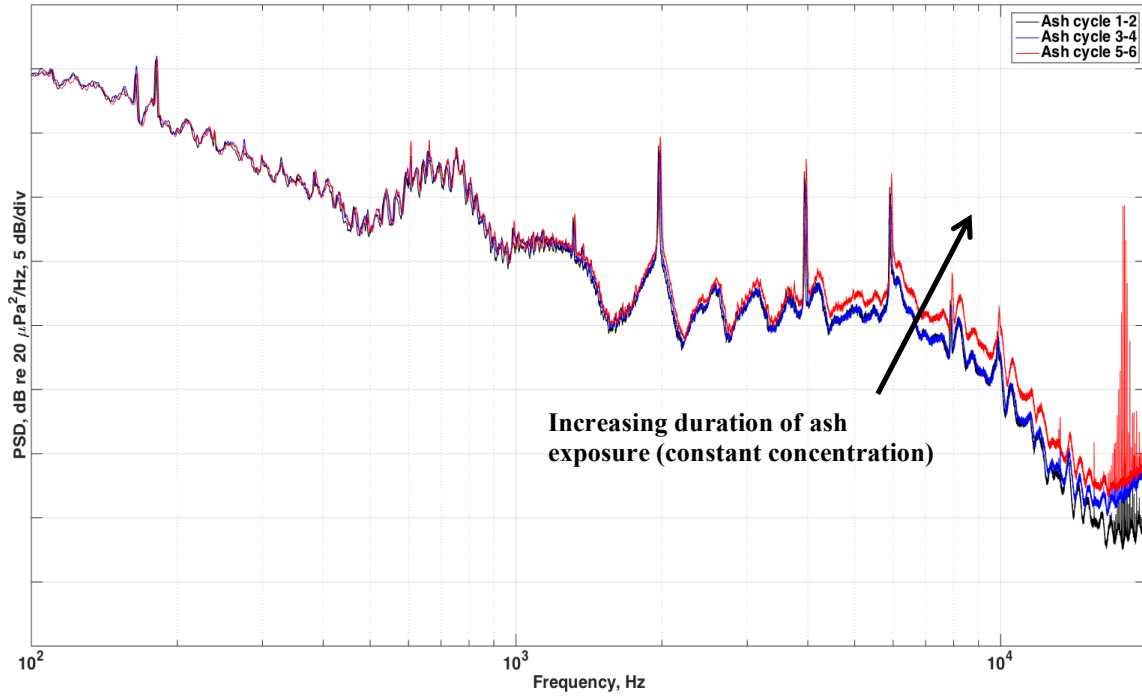
**Figure 5. Power spectral density for microphone A5 for several different ash ingestion cycles during the first “high rate” day of VIPR III VAE testing, showing the trend of reducing level as a function of increasing cumulative ash exposure.**

Taken from the first day of high concentration testing, Fig. 5 shows the PSD plot for the frequency range between 100-20,000 Hz. The microphone location A5 is the second most aft microphone on the aft arc relative to the exhaust centerline. This microphone exhibited the most prominent difference in level as a function of cumulative duration of ash exposure. From the figure it can be seen that the highest levels, particularly at high frequencies, occur chronologically later in the day, and the level increases as the test progresses, with the highest level occurring at the last ash cycle of the day. An ash ingestion cycle, or “ash cycle,” as referenced in the figure, is defined as the period from the start of ash ingestion to the point at which ash flow is stopped to the engine in order to refill the ash hopper. Periodically, events known as shedding of volcanic ash occurred in which visible quantities of ash were exhausted from the engine core in a relatively short period of time. It is unclear yet if those events are individually detectable acoustically and what impact they may have had on reducing degradation. It should be noted that for Fig. 5, two ash cycles are combined for each line shown. Later, each ash cycle is shown individually. The trend continues into the second day of high concentration testing, shown in Fig. 6. The second day of high concentration testing started at a slightly lower spectral level than the first high concentration day. A zoomed section of Fig. 6 is shown in Fig. 7 to more easily discern the changes in spectral level with more ash exposure. Here, each cycle of ash ingestion was captured as a separate signal file, whereas on the previous day each recording contained two cycles. Again, there is a clear increase in spectral power at higher frequencies as a function of more cumulative exposure to volcanic ash. The shift of the tones toward higher frequencies is attributed to the slight increase in rotor speed as temperatures increased throughout the day. The figures present the data from a series of ash ingestion cycles without showing the pre- and post-ash ingestion spectrum. The reason these two periods are omitted from the data is that certain equipment contributing to the overall noise level is not operating at the beginning and end of the test day (it would cause confusion due to the lower level present before ash ingestion). The data presented here show comparable ambient conditions.

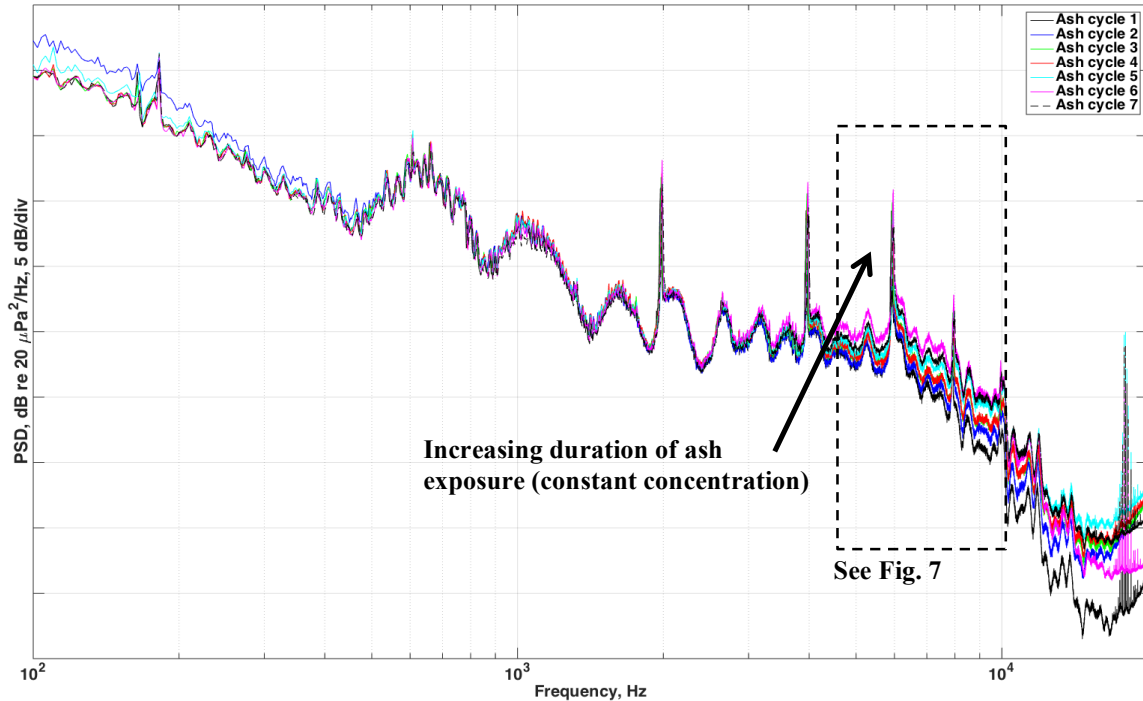
**Figure 6. Power spectral density for microphone A5 for several different ash ingestion cycles during the final day of VIPR III VAE testing, showing the trend of reducing level as a function of increasing cumulative ash exposure.**

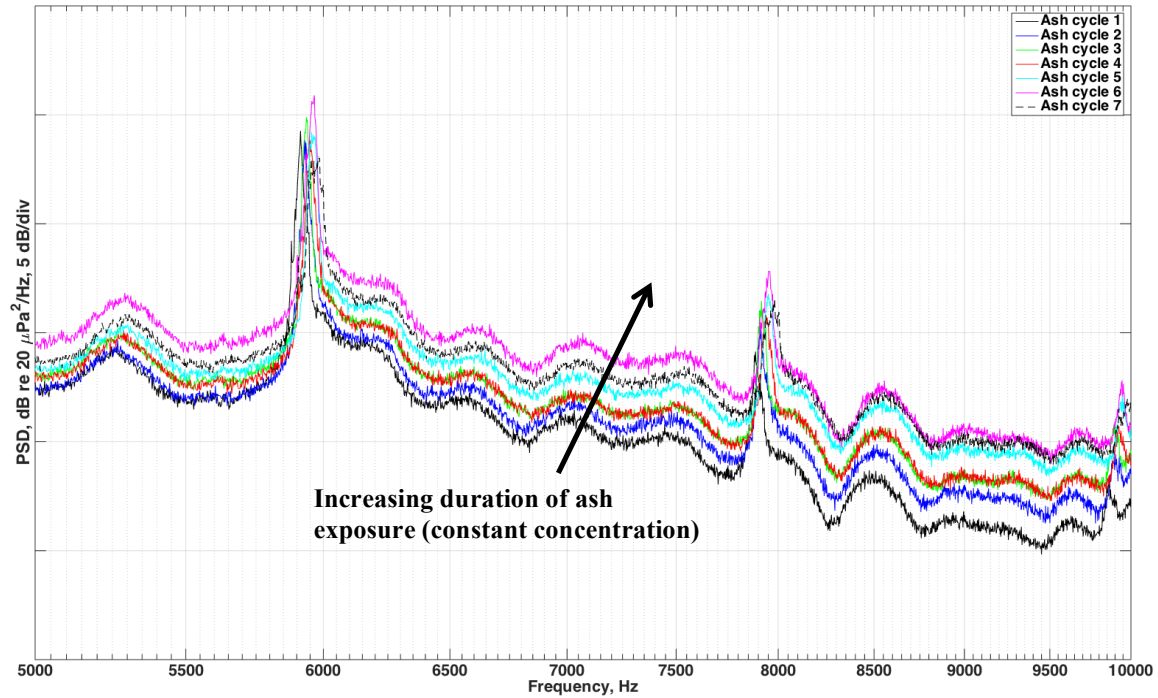
**Figure 7. Power spectral density for microphone A5 zoomed in from 5-10kHz, showing the change more clearly as the engine encounters more ash.**

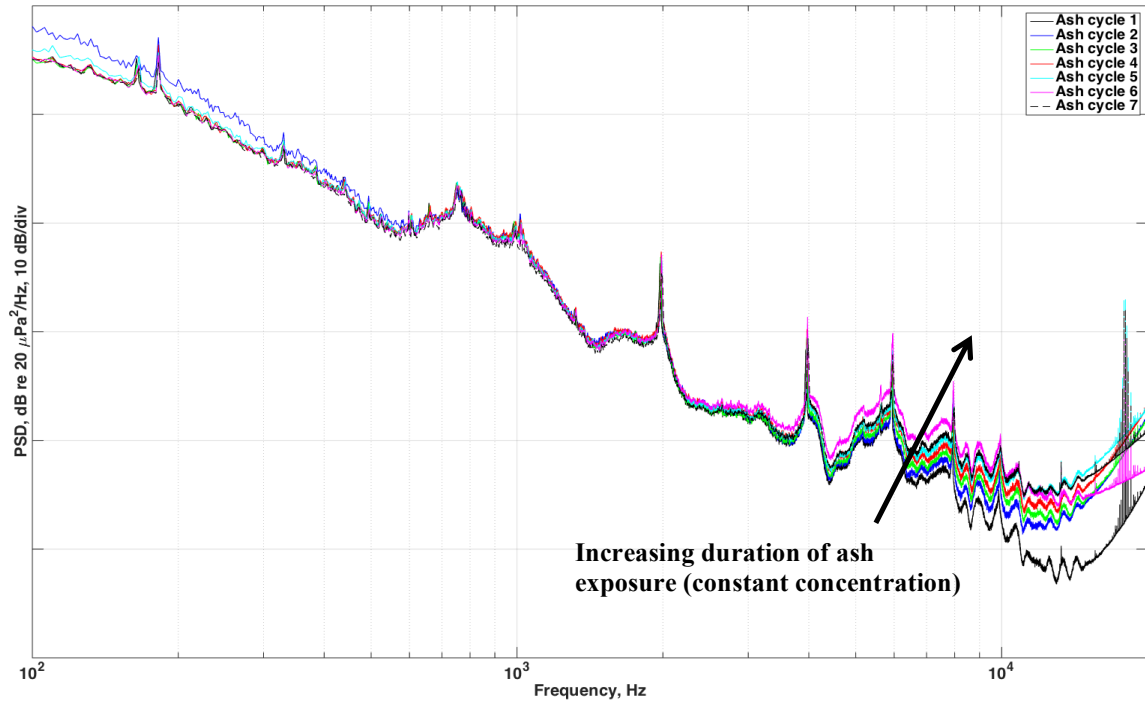
**Figure 8. Power spectral density for microphone A6 for several different ash ingestion cycles during the final day of VIPR III VAE testing, showing the trend of reducing level as a function of increasing cumulative ash exposure.**

Figure 8 demonstrates the same phenomenon at the most aft microphone location A6. Once again, a causal relationship between cumulative volcanic ash ingestion and measurable reduction in spectral power is suggested. The root cause of this change is as yet unclear, but could be from one or several of the degradation mechanisms experienced by turbofan engines in the presence of volcanic ash including: compressor blade erosion, glassification of ash silicates in and around the burner walls and primary combustion zone as well as the first stage turbine vanes and blades, and clogging or erosion of high-pressure turbine cooling passages. This test day included approximately six hours of ash ingestion.

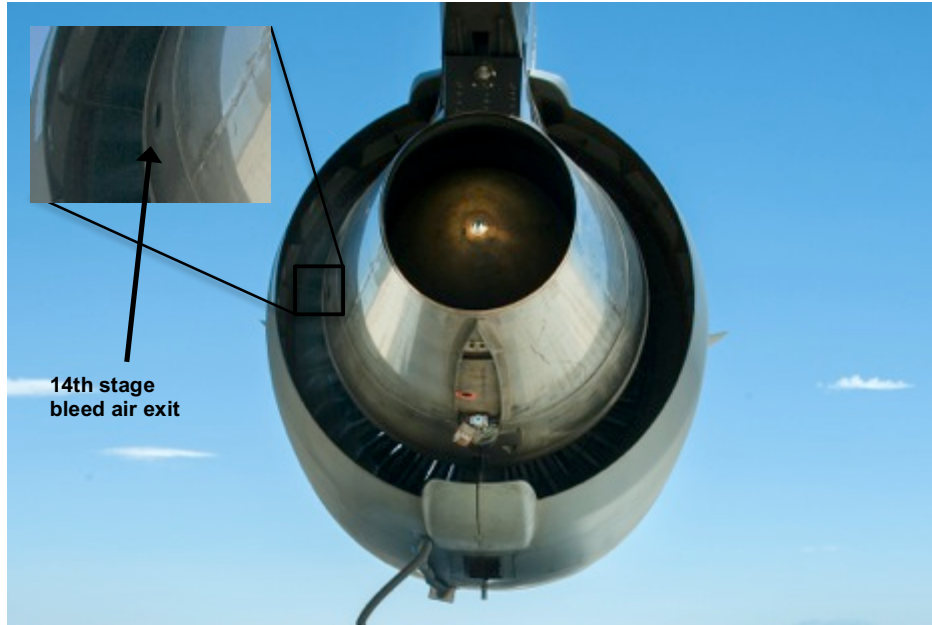
**Figure 9. View of test engine looking forward, showing 14th stage bleed air exit into aft bypass duct.**

As part of the NASA EHM testing, several stability bleed valves were controlled and forced into off-nominal and fail-safe states during different engine performance phases (static and transient operation). The primary motivation for the use of an acoustic array to detect these faults is a potential application in condition-based maintenance practices wherein the faults could be diagnosed and even localized with these and more sophisticated techniques. These faults were also detected by the far-field microphone array in an effort to further characterize different relevant faults and identify spectral uniqueness for diagnostic purposes. The 14th stage bleed valve, operating only in the fully-open or -closed position, dumps excess bleed air from the high-pressure compressor into the aft bypass duct at a single clock location during start and deceleration to maintain a positive pressure gradient at those conditions. See Fig. 9 for visual details of 14th stage bleed air to the aft bypass duct. The first data sets in Figs. 10 and 11 show aft microphones A4 and A6, respectively, spectral density plots with curves corresponding to noise spectra prior to and after the simulated faulting of the 14th stage bleed valve to its fail-safe fully-open position during a constant power setting. There is a clear and audible broadband noise increase after the valve is opened.

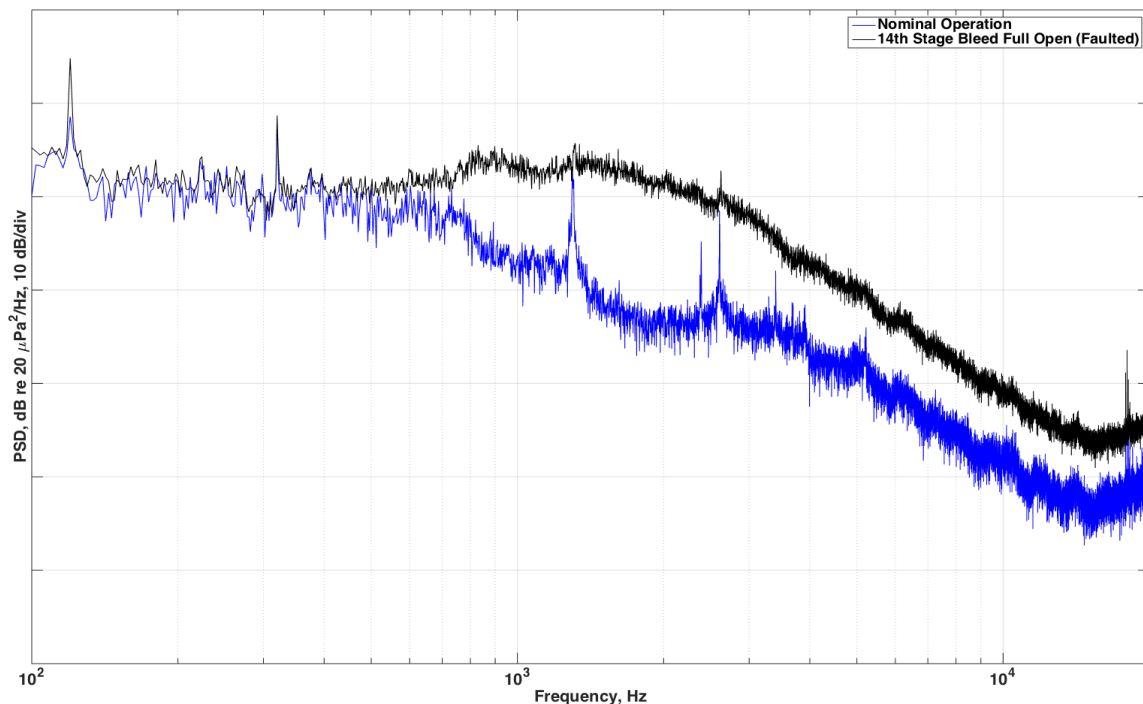
**Figure 10. Power spectral density for microphone A4 for simulated failure of the 14th stage bleed valve during steady-state engine operation.**

At higher power settings, if the valve fails, it slews open, releasing high-pressure compressor air into the bypass duct, creating a penetrating jet condition with the bypass flow. The noise propagates out the forward and aft bypass duct, as is evidenced by Figs. 10 and 11, and can be seen forward as well in Fig. 12 (microphone location F2, 30 deg relative to inlet centerline axis). Figure 13 shows the aft microphone, A1, at the greatest angle relative to the jet exhaust axis. The change as a result of opening the valve is still plainly evident.

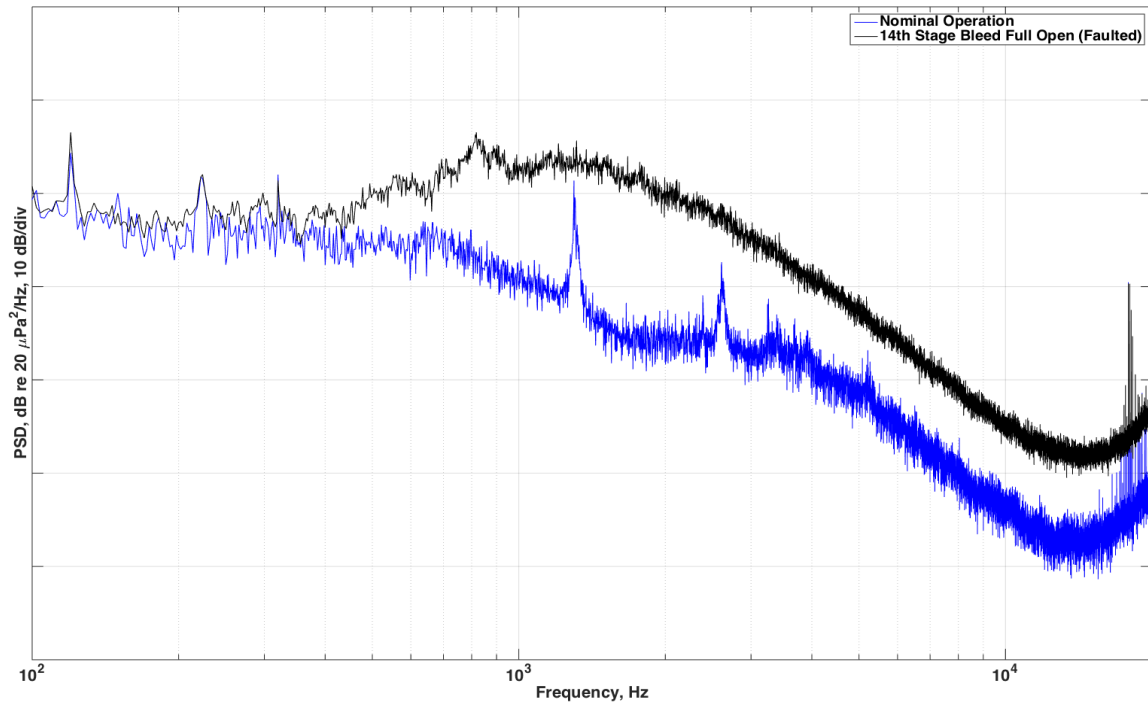
**Figure 11. Power spectral density for microphone A6 for simulated failure of the 14th stage bleed valve during steady-state engine operation.**

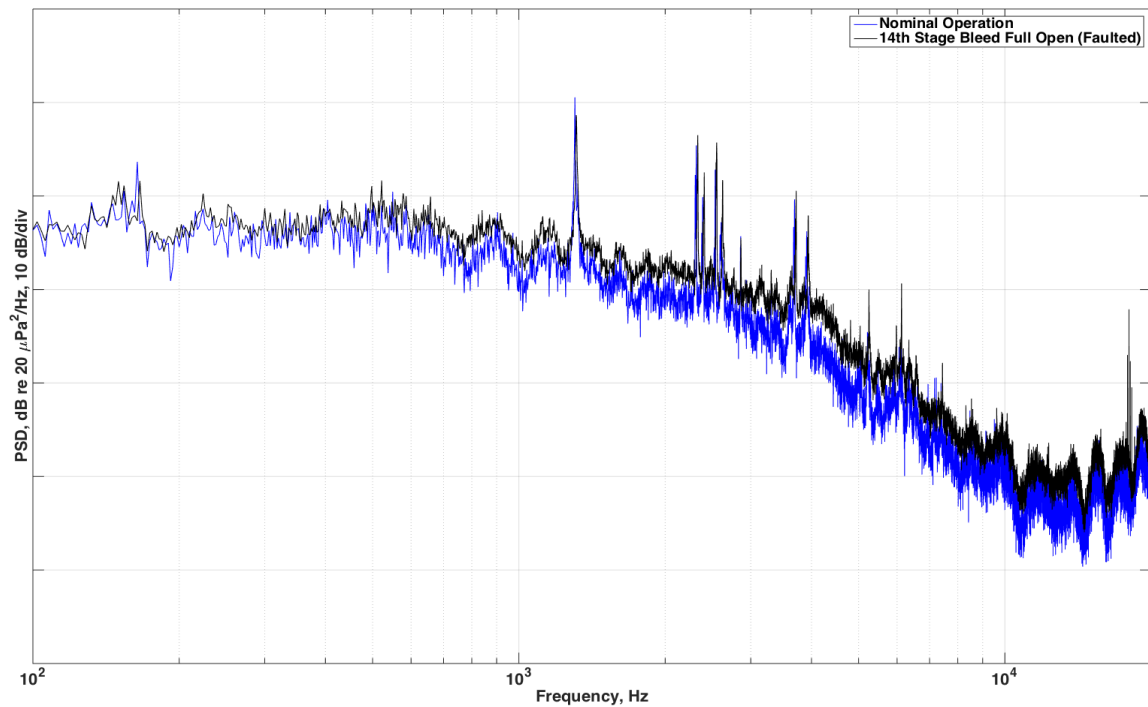
**Figure 12. Power spectral density for microphone F2 for simulated failure of the 14th stage bleed valve during steady-state engine operation.**

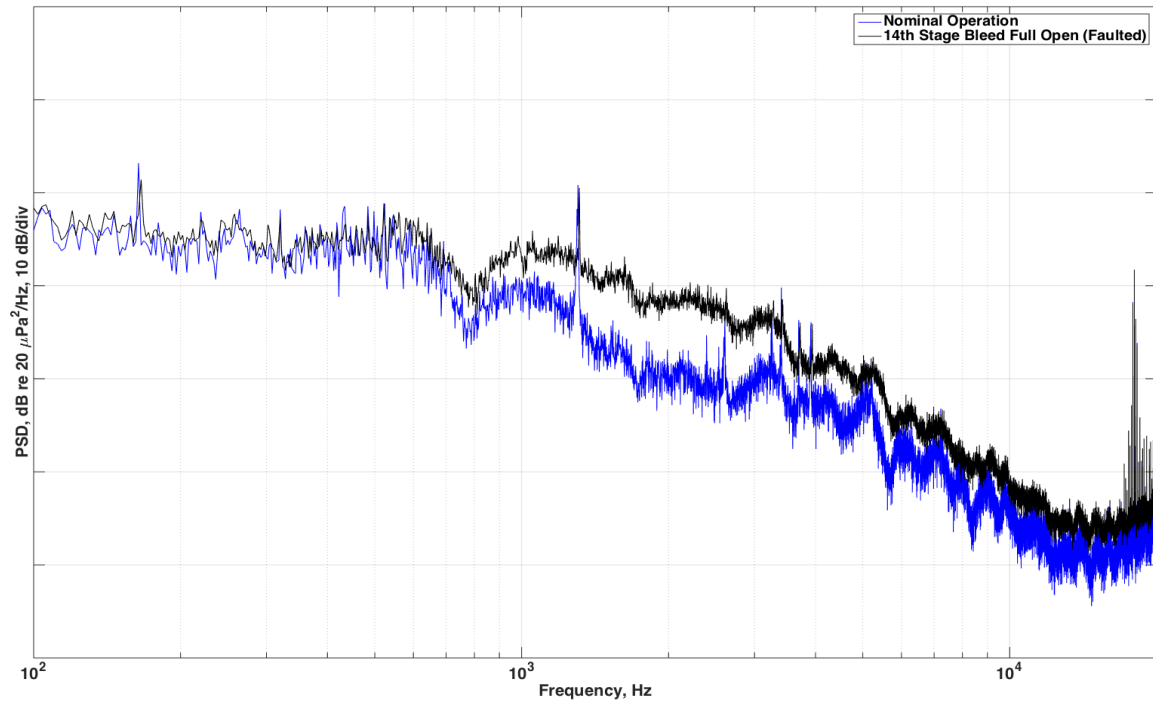
**Figure 13. Power spectral density for microphone A1 for simulated failure of the 14th stage bleed valve during steady state engine operation.**

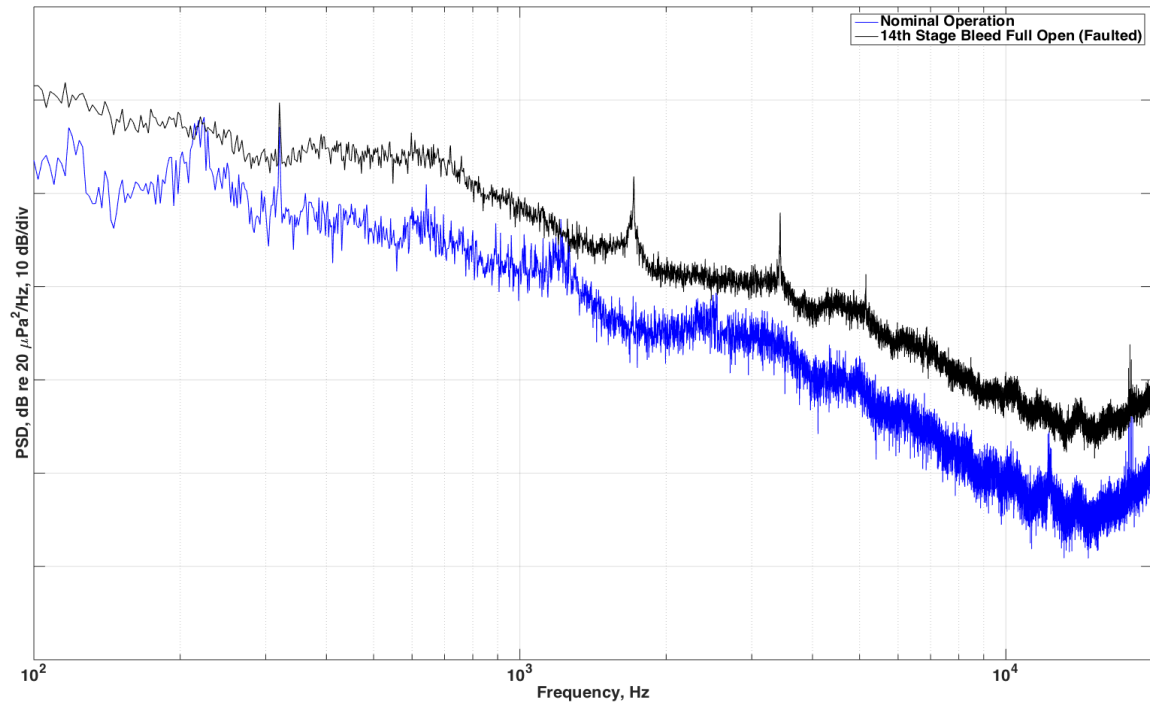
**Figure 14. Power spectral density for microphone A4 for simulated failure of the 14th stage bleed valve during ramp acceleration profile.**

Beyond the steady-state operation, simulated valve failures were performed during throttle transients including relatively slow throttle advances and rapid advances of the throttle (referred to here as “ramp” and “snap,” respectively). These profiles were performed in two phases: the baseline run with no fault insertion, and the same maneuver with the fault inserted at a particular point, simulating the failure of the valve during a throttle transient. Figures 14 and 15 show the ramp acceleration noise spectra for microphones A4 and A6, respectively. Once again, a broadband increase in the spectra is prominent. The same trend holds true for the case of the snap acceleration profile, the spectra for which are shown for microphones A4 and A6, respectively, in Figs. 16 and 17.

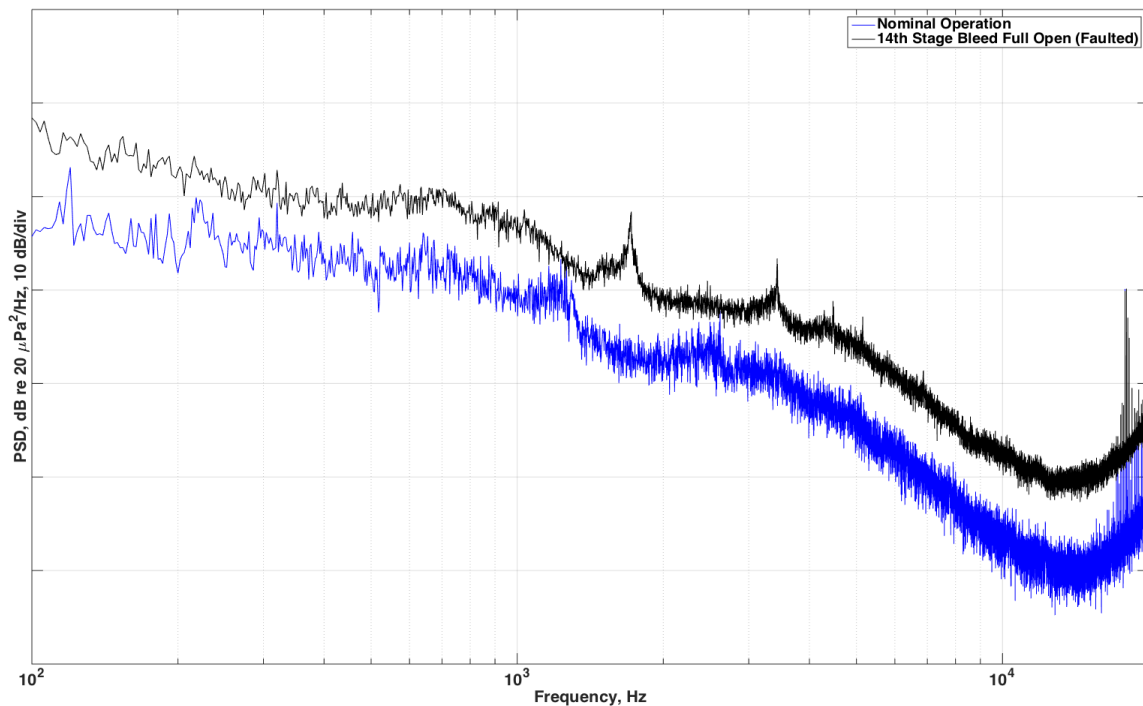
**Figure 15. Power spectral density for microphone A6 for simulated failure of the 14th stage bleed valve during ramp acceleration profile.**

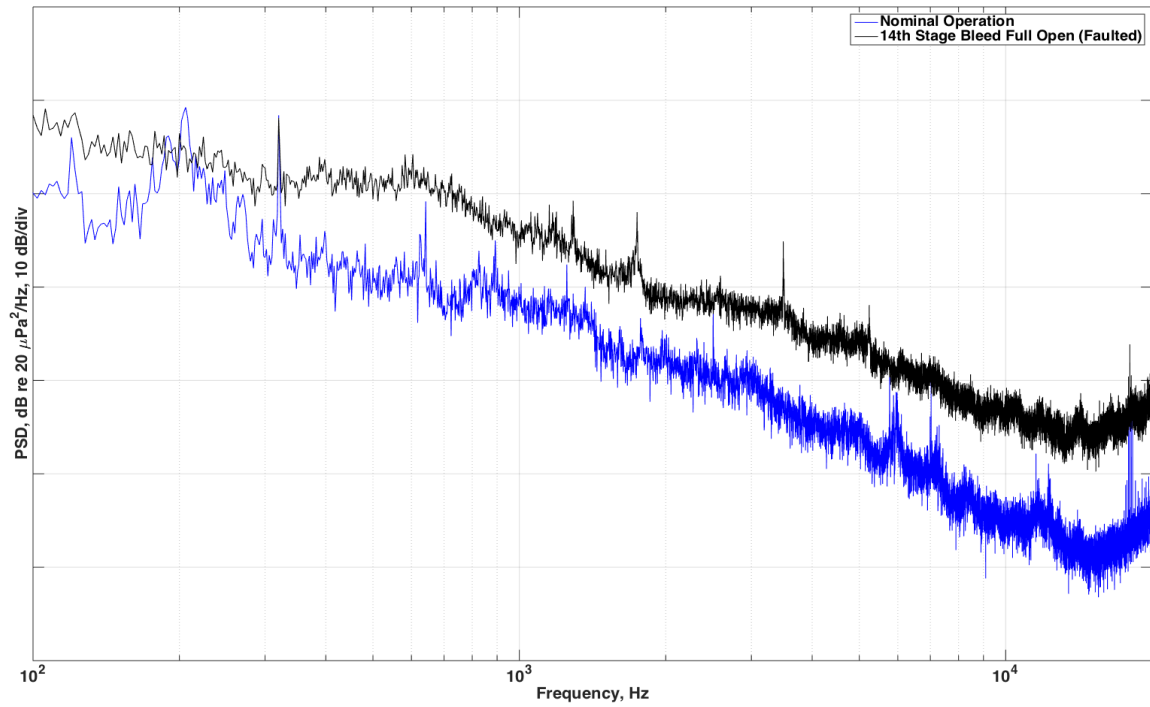
**Figure 16. Power spectral density for microphone A4 for simulated failure of the 14th stage bleed valve during snap acceleration profile.**

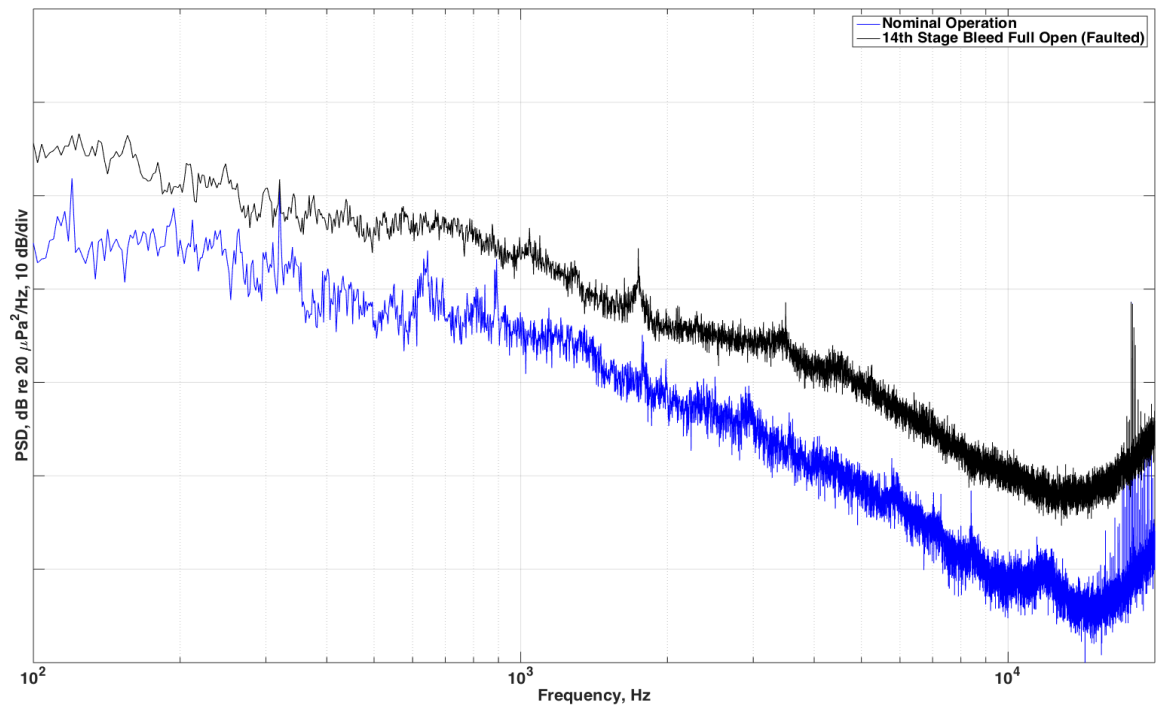
**Figure 17. Power spectral density for microphone A6 for simulated failure of the 14th stage bleed valve during snap acceleration profile.**

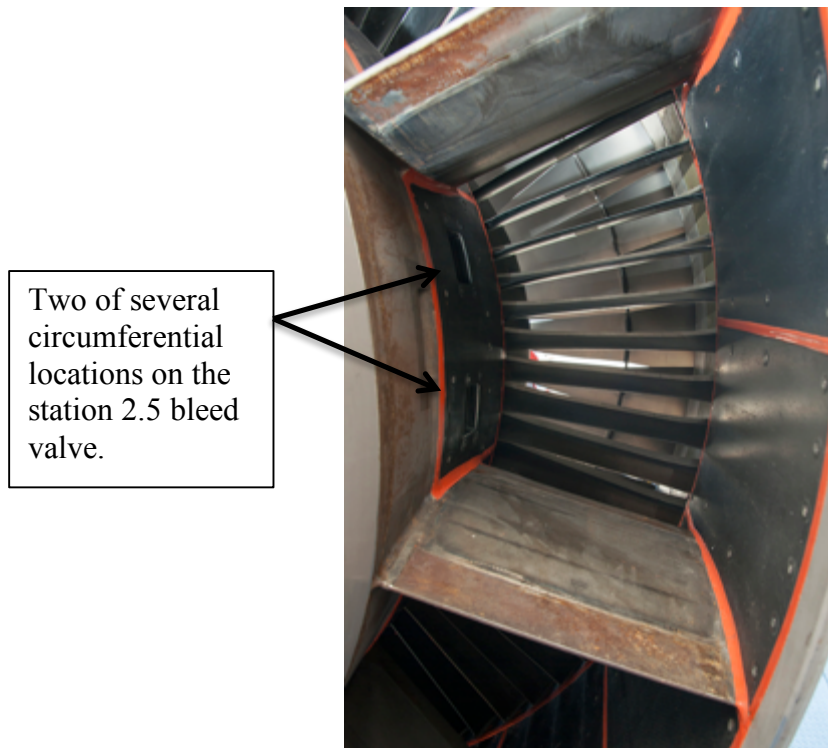
**Figure 18. Fan bypass duct looking forward, showing two of several circumferential locations on the station 2.5 bleed manifold.**

Simulated failure of the station 2.5 stability bleed valve was conducted during steady-state, ramp, and snap acceleration throttle movements. For several reasons, the detection of the station 2.5 fault was difficult. Firstly, the pressure at station 2.5 (low-pressure compressor exit / high-pressure compressor inlet) is substantially lower than at the 14th stage. Secondly, the valve is modulated from fully open at idle to fully closed before reaching maximum power. As such, the valve is still partially open when it is commanded to its fail-safe fully-open position as opposed to the discretely operating 14th stage valve. Additionally, the station 2.5 bleed valve dumps bleed air at several circumferential locations around the forward bypass duct by way of several rectangular openings in a ring manifold, meaning that the pressure release is distributed around the bypass duct. All of these factors contributed to the relative difficulty of discerning changes in the spectral noise due to the simulated failure of the station 2.5 stability bleed valve. Figure 18 offers some perspective on how the station 2.5 bleed air is dumped into the bypass duct. The difference between the nominal and faulted state was evident for the most forward microphone, F1, seen in Fig. 19.

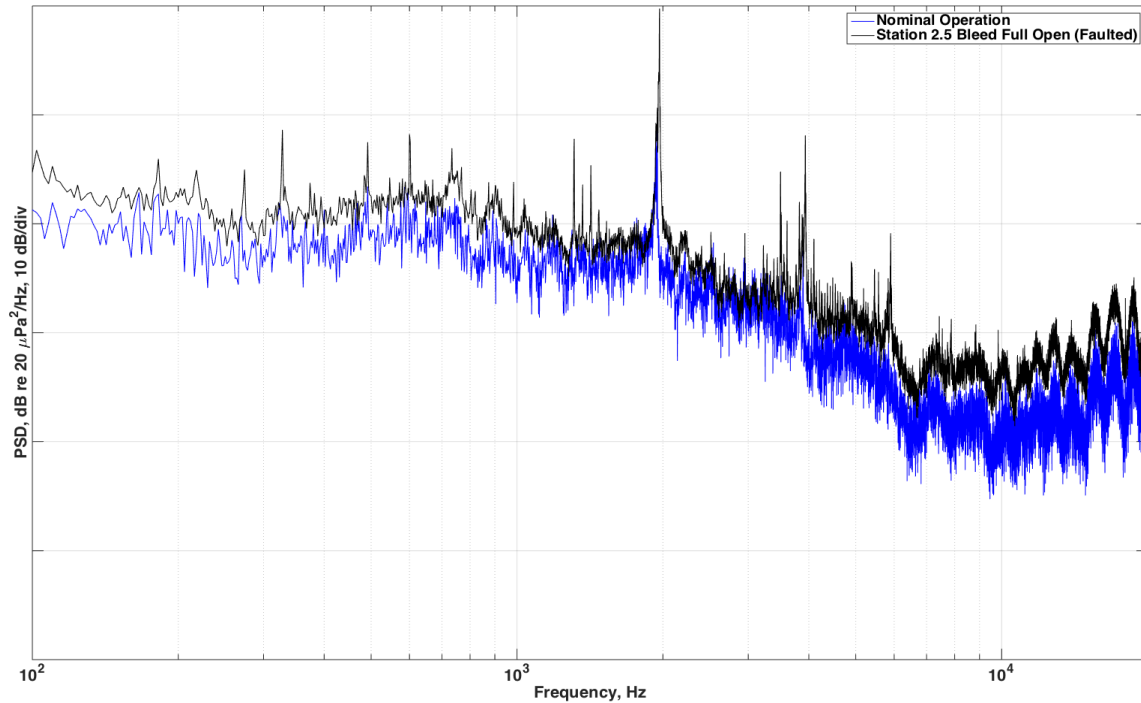
**Figure 19. PSD for microphone F1 for simulated failure of the station 2.5 bleed valve during snap acceleration profile.**
